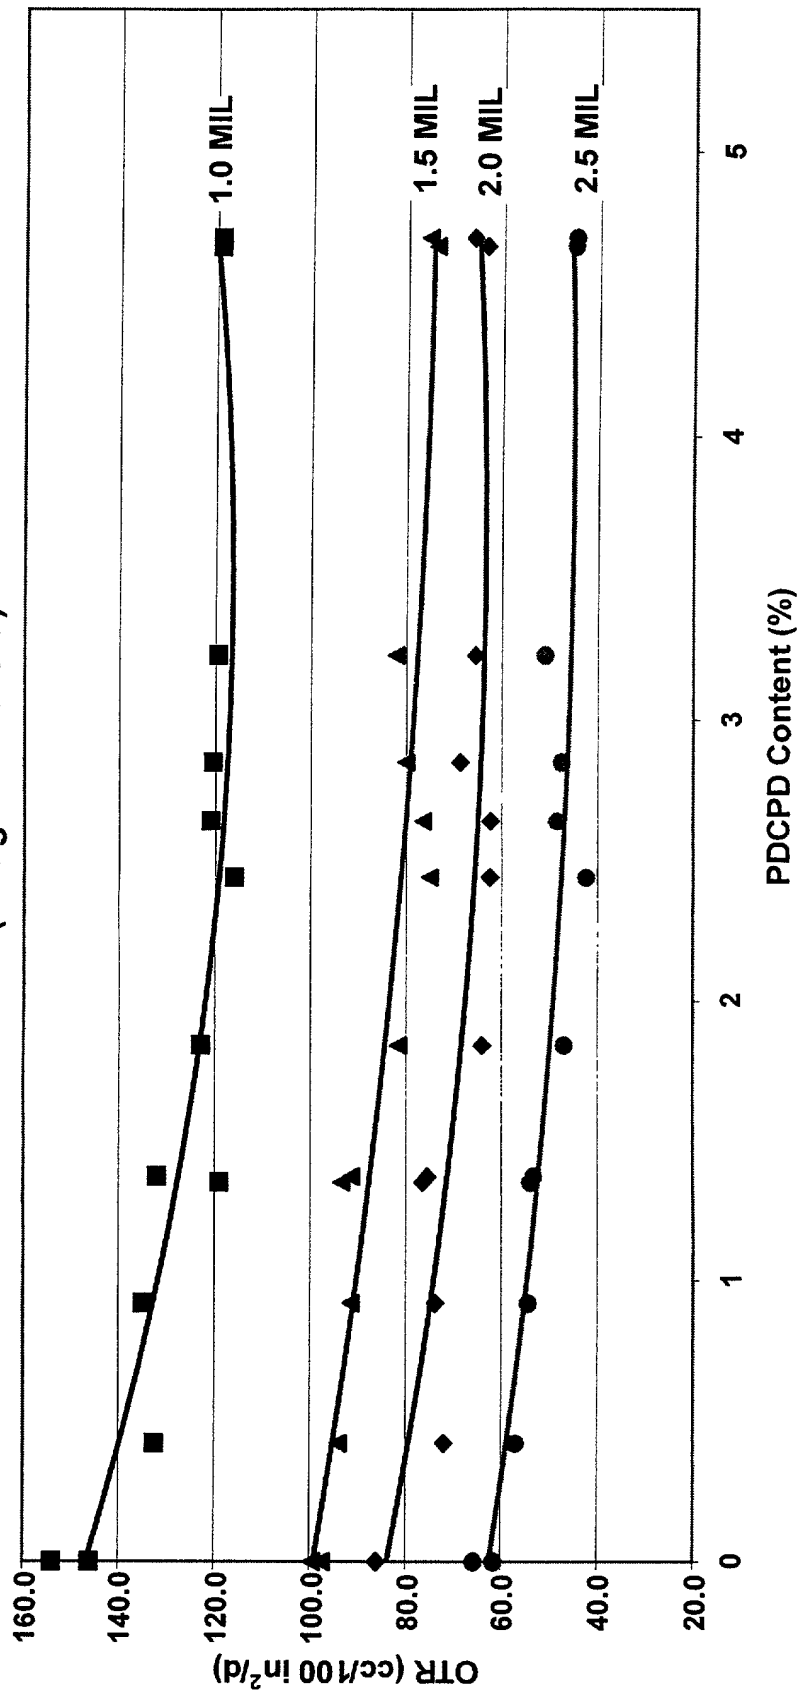
Figure 4

OTR (Gauge Corrected)

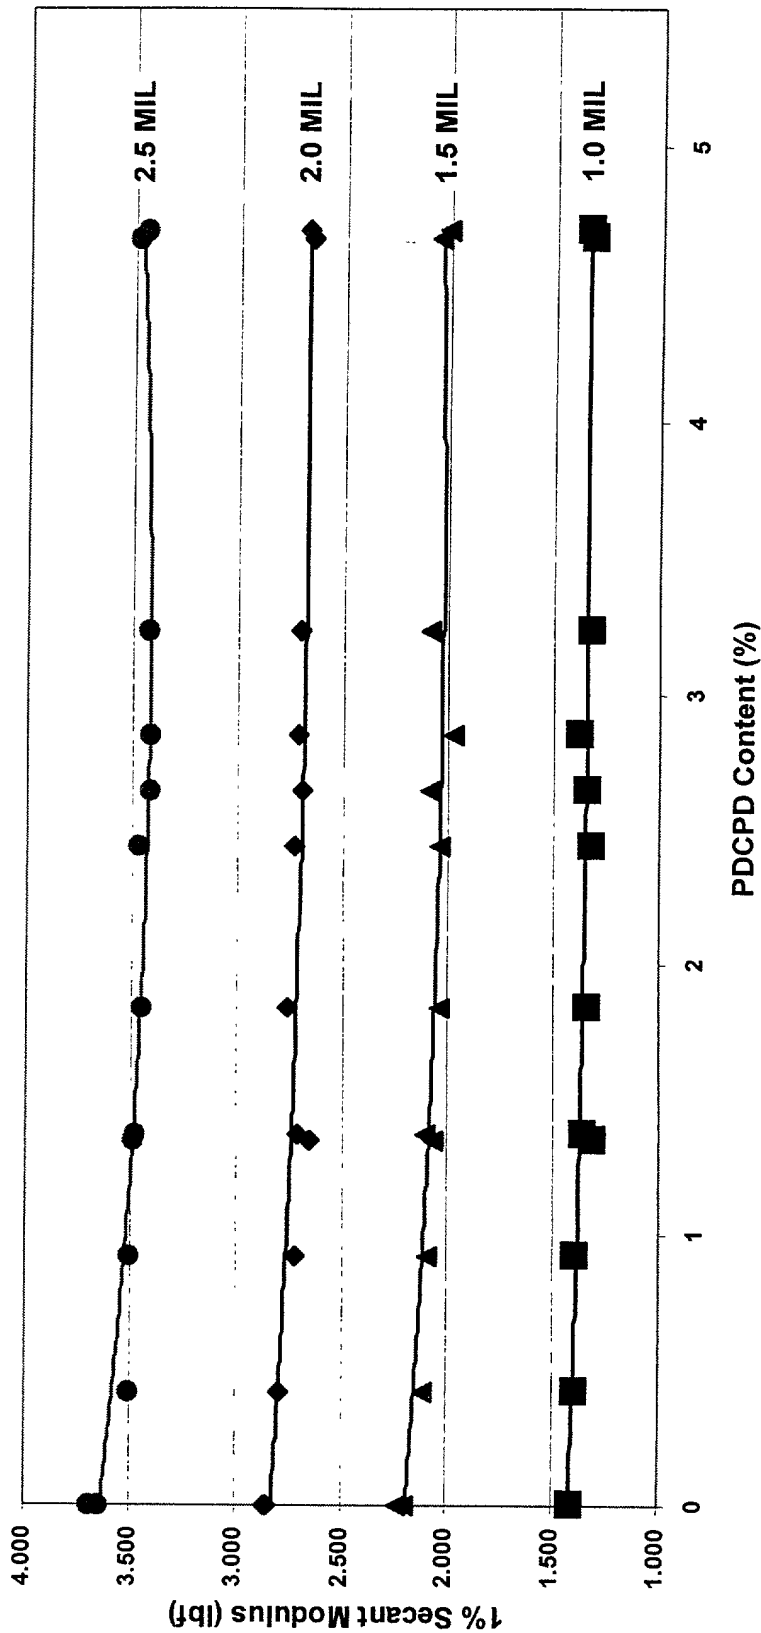
Figure 5

1% Secant Modulus  
Machine Direction

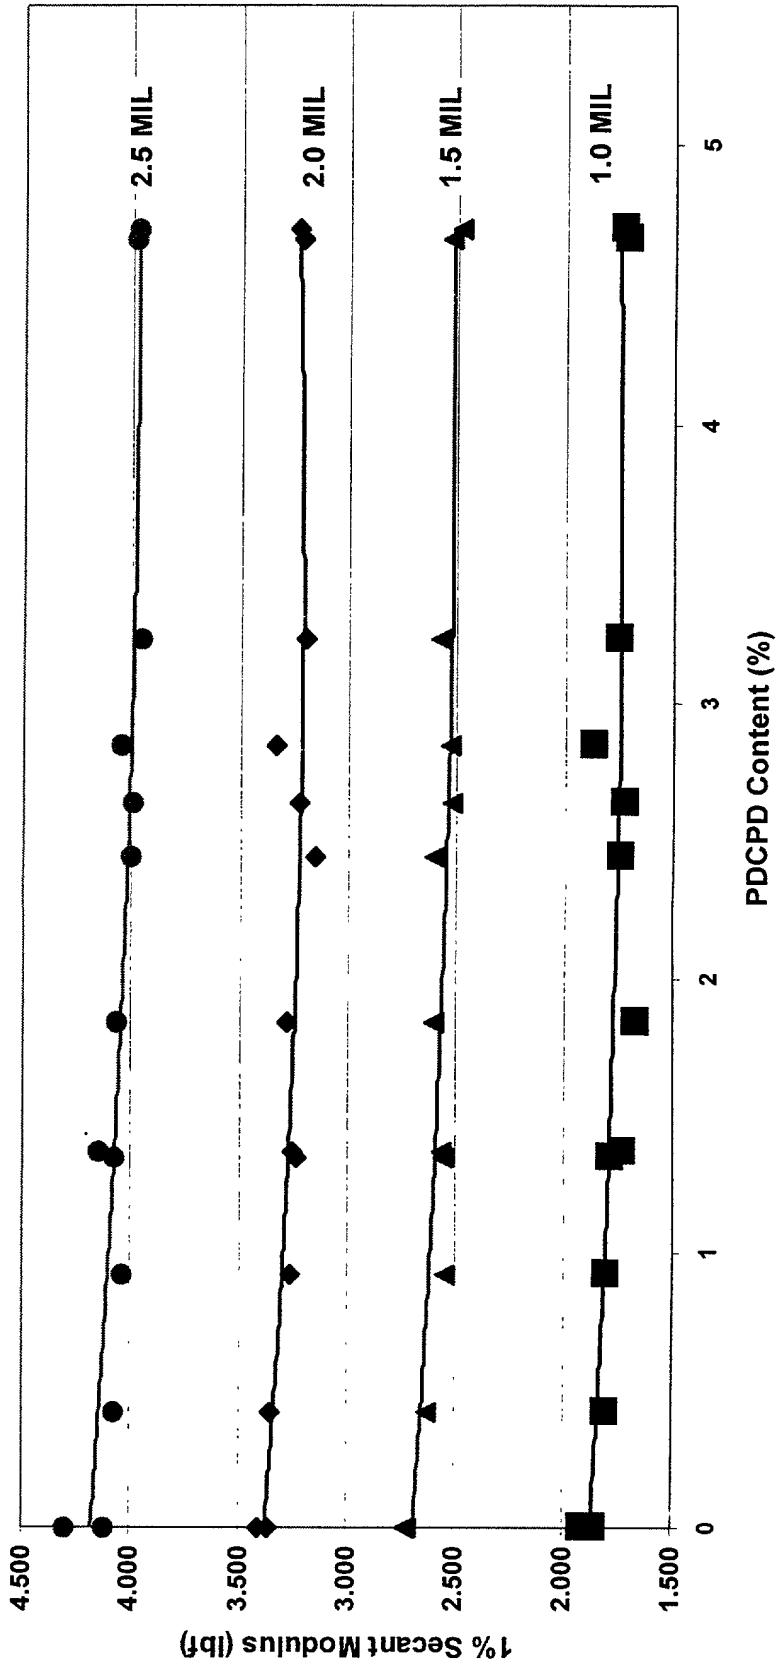
Figure 6

1% Secant Modulus  
Transverse Direction

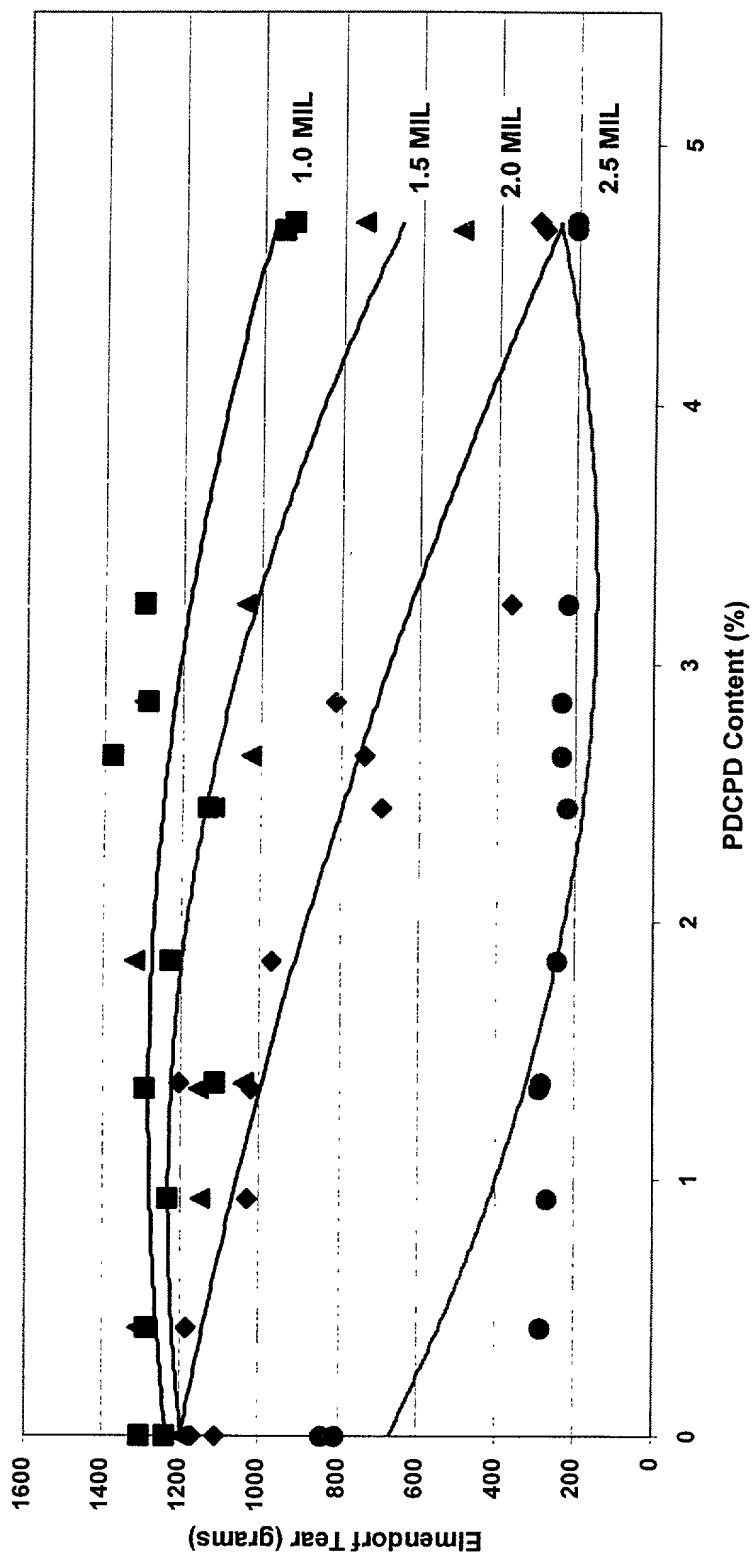
Figure 7

TD Elmendorf Tear
